# Citizen Volunteer Water Quality Monitoring on Alabama's Coast

## Dog River

Alabama Water Watch  
September 2004

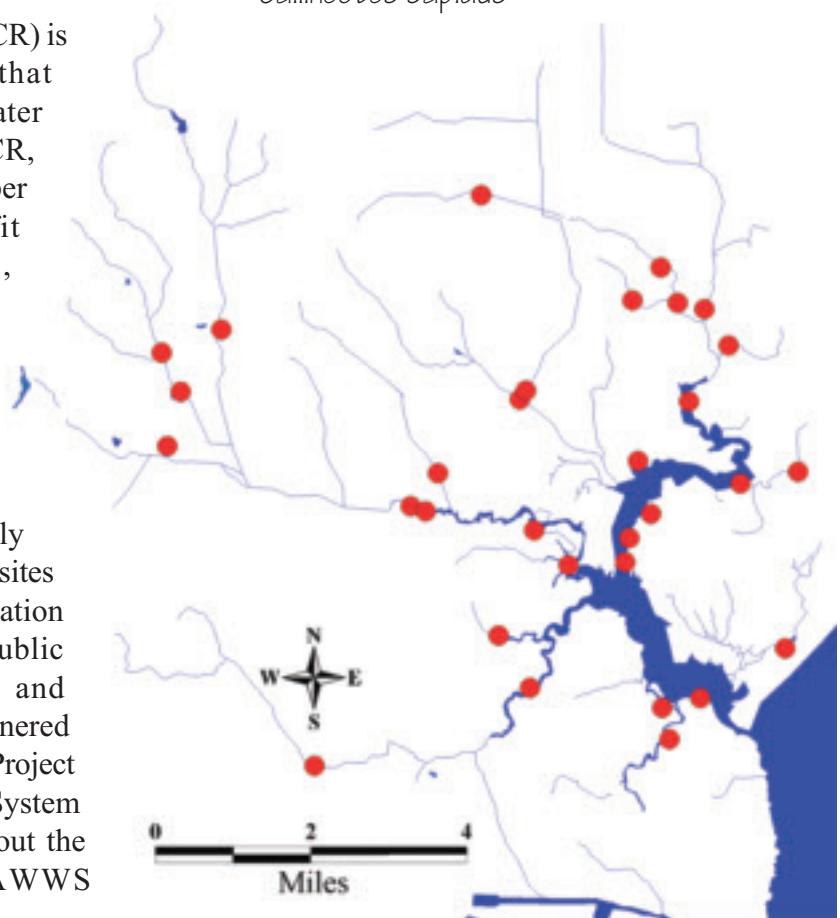
Dog River Clearwater Revival sampling sites (●)

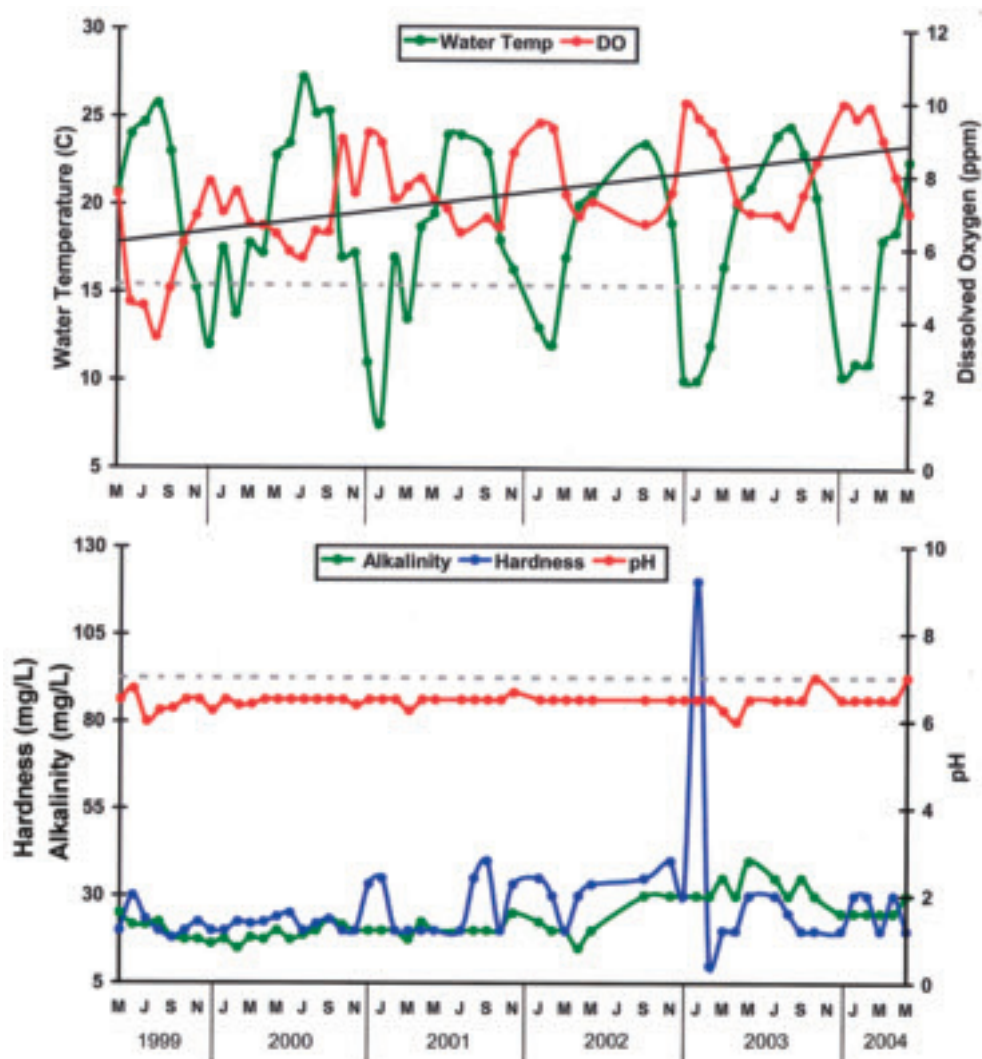
Site 9 (06005009) - Ken MacRae and Rob Nygren  
Halls Mill Creek at Halls Mill Road

- The water temperature of Halls Mill Creek (Site 9) ranged from about 27 C (81 F) in the summer to about 7 C (45 F) in the winter. Dissolved oxygen (DO) concentrations varied inversely with temperature (as expected) and ranged from about 4 parts per million (ppm) in the summer of 1999 to 10 ppm in the winter of 2004. As indicated by the black trend line, the DO at this site seems to be increasing over the last five years and is now well above the minimum Fish and Wildlife standard (5 ppm, gray dashed line) for supporting aquatic life.

- The pH at Site 9 was stable and mildly acidic (slightly below the gray dashed line which indicates a neutral pH of 7), typical of many coastal streams. Alkalinity and hardness were also relatively stable and ranged from 10-40 mg/L, except for a spike in hardness of 120 mg/L in January 2003. The sharp increase in hardness followed a heavy rain and was probably caused by polluted runoff to the stream.

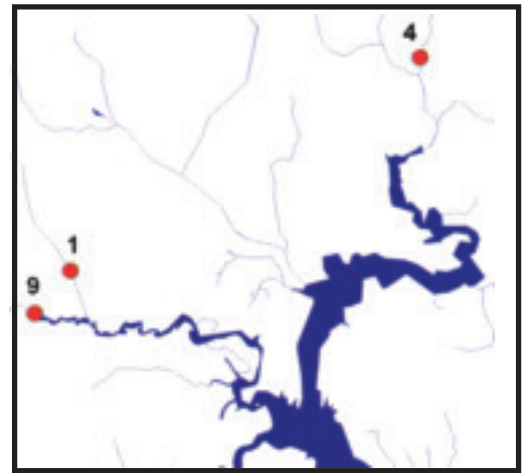
DRCR sites 1, 4 and 9 in the Dog River watershed

- The graphs on pages 6-8 document both seasonal and multi-year changes in water quality at three DRCR sampling sites (see map on p. 7). Each data point on a graph represents the average of one to several measurements per month.

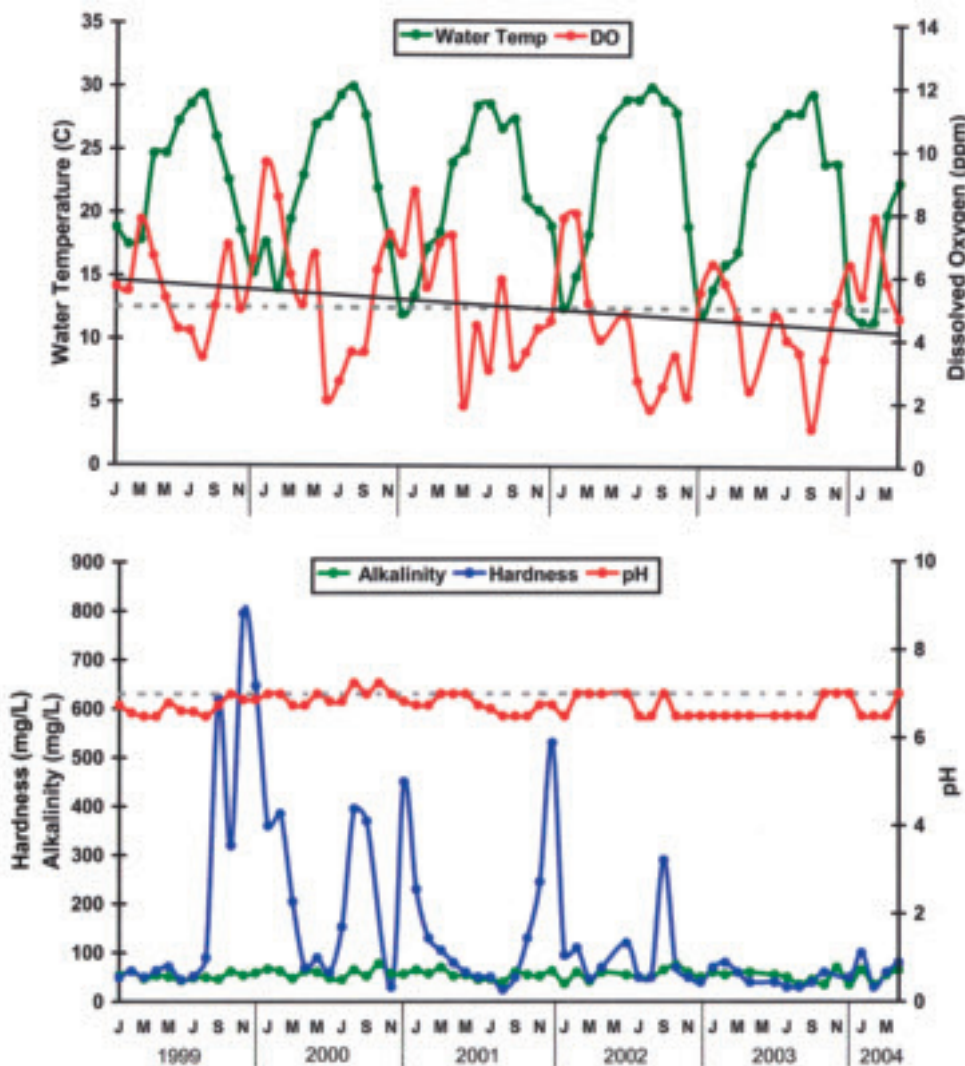
### Site 4 (06005004) - Mimi Fearn Eslava Creek at McVay Road

- The water quality of Eslava Creek (Site 4) was quite different from that of Halls Mill Creek. Eslava Creek had higher water temperatures (14-30 C or 57-86 F).

- DO levels (black trend line) in Eslava Creek had the opposite trend of Halls Mill Creek and have steadily declined to values that are detrimental to fish and other aquatic life.

- Because the stream is of a lower quality than its use classification (Fish and Wildlife), it is a candidate for an ADEM and EPA registry of impaired streams called the 303(d) List. Low DOs and higher temperatures are probably because the subwatershed is more urbanized, the headwaters have been diverted, and the stream is often stagnant.

- The pH of Eslava Creek was similar to Halls Mill Creek, mildly acidic. Alkalinity was also generally similar, but hardness values at Site 4 had abrupt peaks with monthly averages that reached 400-800 mg/L. The highest single-date value for hardness at site 4 was about 2,000 mg/L on September 26, 1999! The hardness peaks occurred during dry periods (especially during the drought years of 1999-2001) and were caused by brackish water intrusion (high in calcium and magnesium) from the bay. Alkalinity remained low while hardness peaked because brackish water is not high in carbonates and bicarbonates.

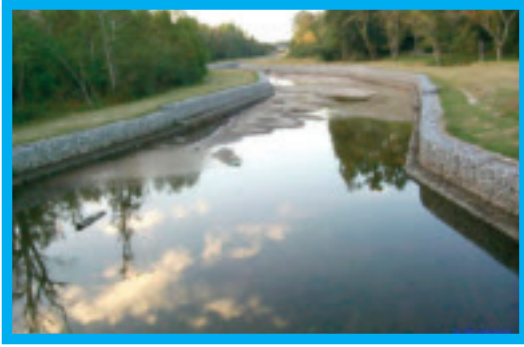
A channelized section of Spring Creek with streamside vegetation removed

- The water temperature of Spring Creek (Site 1) over the last five years seems to have an increasing annual range (higher in summer, lower in winter). This is probably because the streamside vegetation has been removed, exposing the stream to more sunlight and a wider range of air temperatures. The site also has had greater seasonal fluctuations in DO over time that may be related to changes in the streamside cover or flow. However, the DO has remained equal to or above 5 ppm.

of major channelization of Spring Creek, when natural, riparian vegetation was replaced with extensive limestone riprap. Limestone is calcium carbonate, which increases both alkalinity and hardness of water when it dissolves.

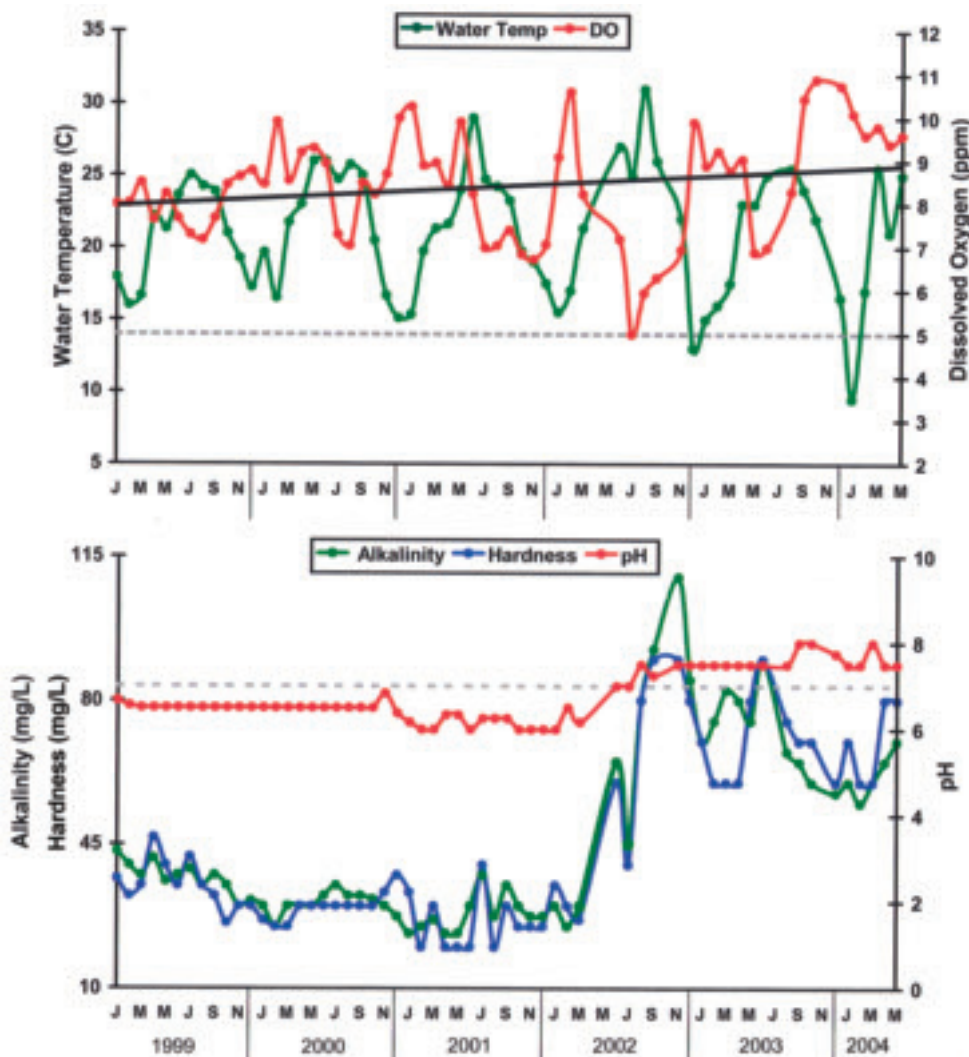
Site 1 (06005001) - Mimi Fearn, Rob Nygren and Gaye Hadley  
Spring Creek at Halls Mill Road

- Alkalinity, hardness and pH values at Site 1 were all within expected, natural limits from 1999 through early 2002. Then, the values abruptly increased and alkalinity and hardness more than doubled. This appears to be a result

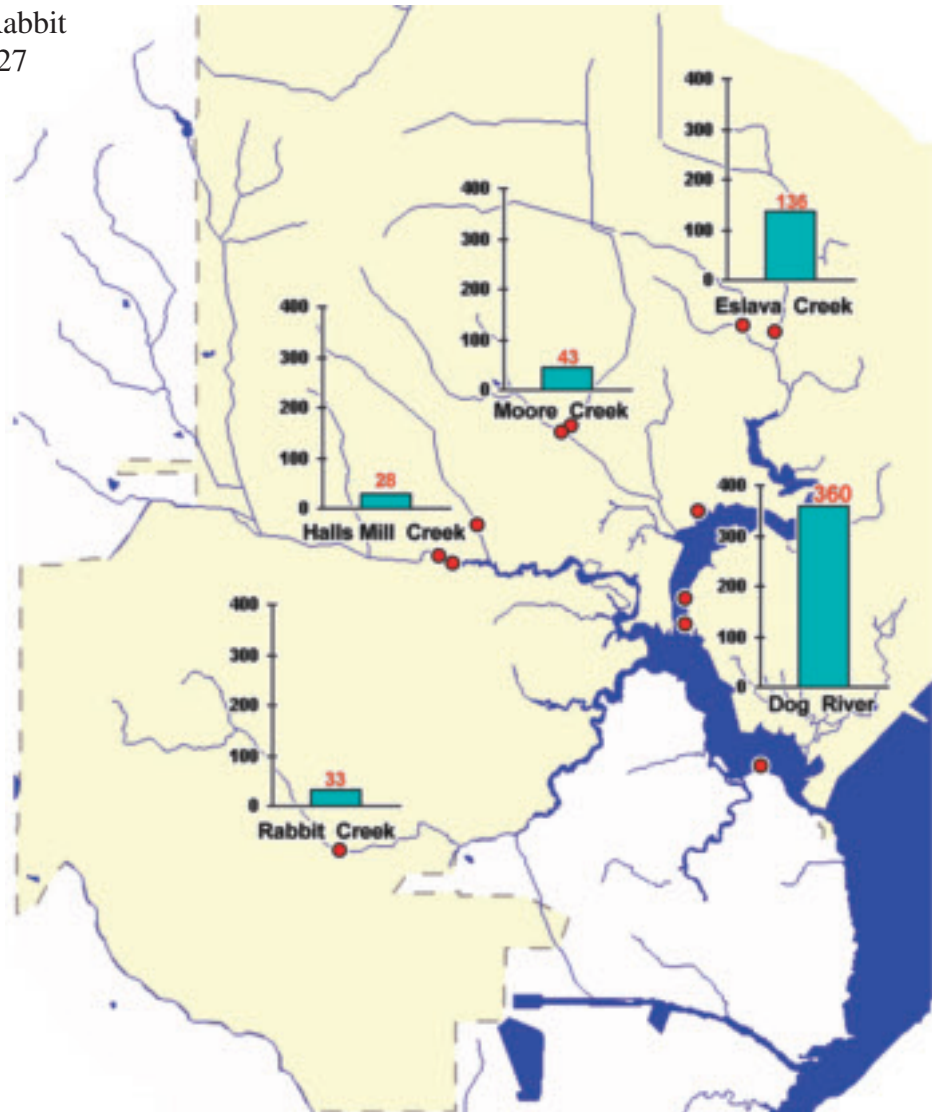
- A comparison of average water hardness values (concentration of calcium and magnesium) of four tributary streams and Dog River (a brackish water bay) reveals major differences within the watershed. Graphs are based on 940 hardness measurements at 12 DRCR sites (Sites 4 and 18 on Eslava Creek; Sites 2 and 3 on Moore Creek; Sites 1, 9 and 10 on Halls Mill Creek; Site 17 on Rabbit Creek; and Sites 6, 19, 20 and 27 on Dog River), collected from 1999 to 2004.

- Three of the tributary streams, Moore, Halls Mill and Rabbit creeks, had average hardness values of 28-43 mg/L, typical of “soft” waters of coastal areas. Dog River had a hardness that was about 10-times higher than these tributaries because it is tidally influenced and moderately brackish.

- The average hardness of two sites on Eslava Creek was more than 3-times higher than the other three creeks. The construction of Interstate 65 in the 1960s severed the headwaters from Eslava Creek and diverted them into Montlimar Canal. Because the stream is usually stagnant, it is more tidally influenced by high-hardness, brackish water of Dog River.

- AWW water monitors act as detectives that “sleuth out” causes and effects of water pollution, stream alterations or other changes that affect a waterbody. By overlaying graphs of DRCR water data on a map of Dog River, it is easier to understand what is happening to water quality throughout the watershed.

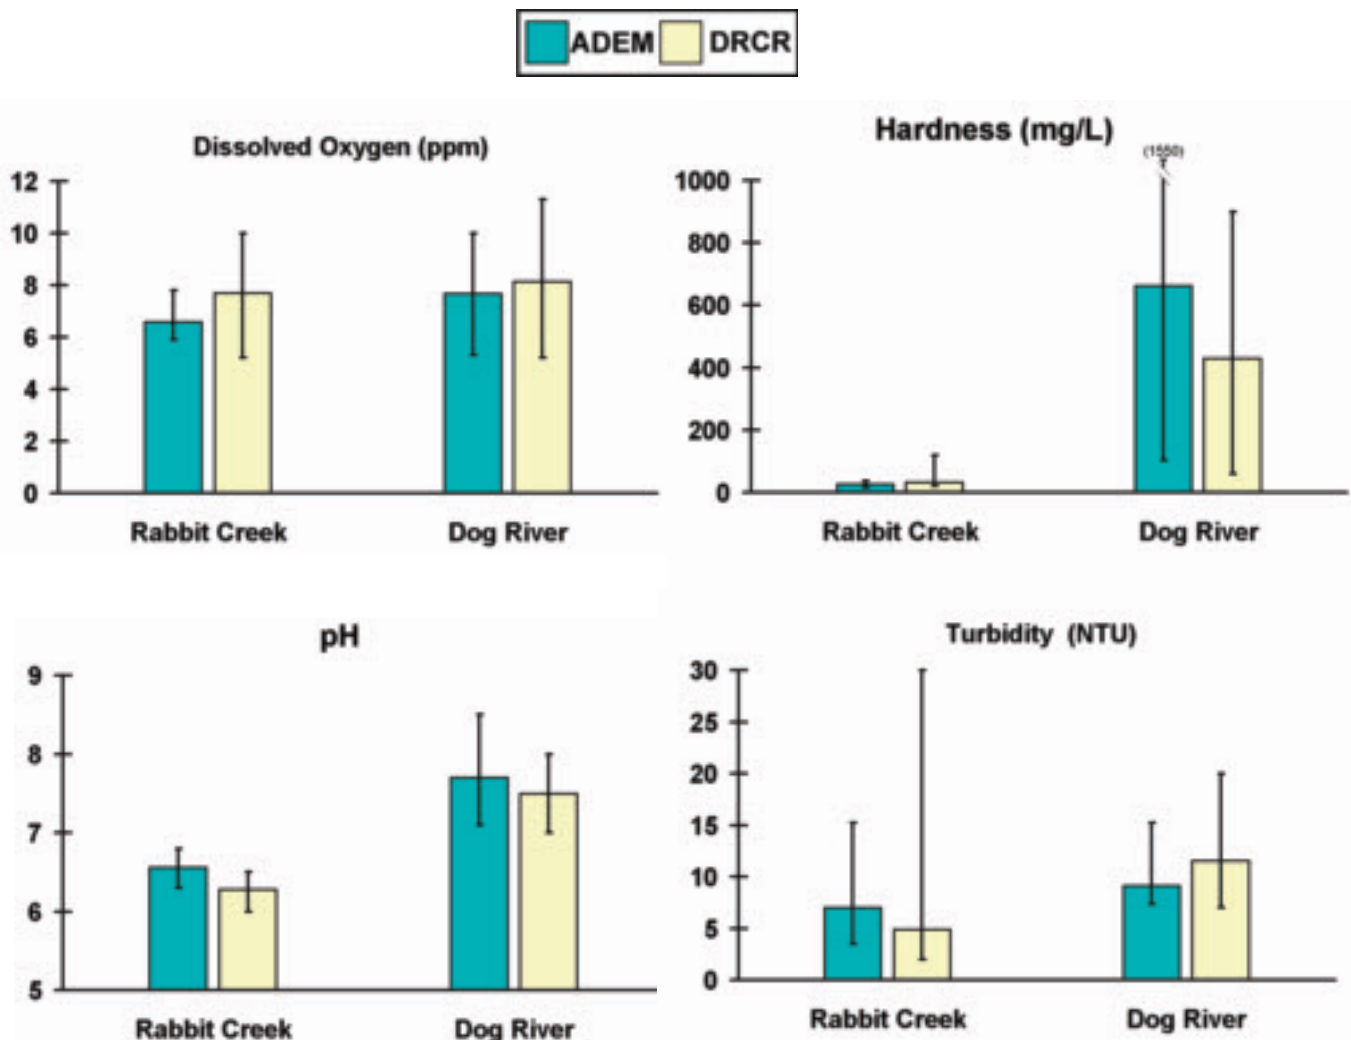
DRCR Sites 17 (06005017) and 8 (06005008) with ADEM sites RBTM-3 and DGRM-2 (ADEM 2003). Bars represent the average value of a parameter. Lines within bars represent the range of values.

- By comparing DRCR water chemistry data to professional data collected at about the same time and place, the credibility of the citizen data can be evaluated. In the graphs above, 41 records of DRCR from 1999-2003 were compared to 12 data records of the Alabama Department of Environmental Management (ADEM) from 2001.

- The two data sets were generally comparable and revealed water quality differences between Dog River and Rabbit Creek. Average dissolved oxygen, hardness, pH and turbidity were all higher in Dog River than in Rabbit Creek, as documented by both DRCR and ADEM. DRCR had more than 3-times the data records to substantiate these conditions, and they also are the only group collecting data from several other sites in the watershed.

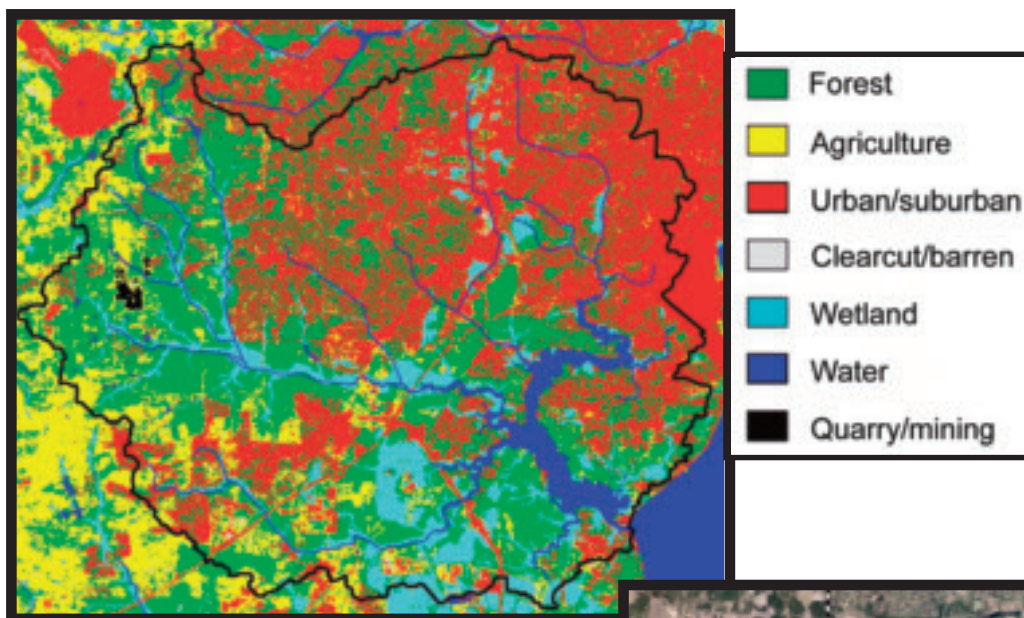
A land use map generated from 1992 Landsat satellite imagery of the Dog River watershed (delineated with black line)

- A comparison of these two watershed images indicates significant land use changes over a 10-year period. The 2002 image (right) shows evidence of increasing urbanization in the western and southern portions of the Dog River watershed.
- Relatively open, forested areas have decreased and developed plots have increased in the upper Halls Mill Creek and Rabbit Creek watersheds. Such development tends to decrease water infiltration and increase runoff that transports sediment, nutrients, pathogens and other pollutants to tributaries of Dog River.
- Given this trend of increased urbanization, it is important to continue monitoring the water quality of the creeks and bayous of the Dog River watershed and to put the DRCR information to use in environmental education, stream restoration and improved policies for protecting the watershed.

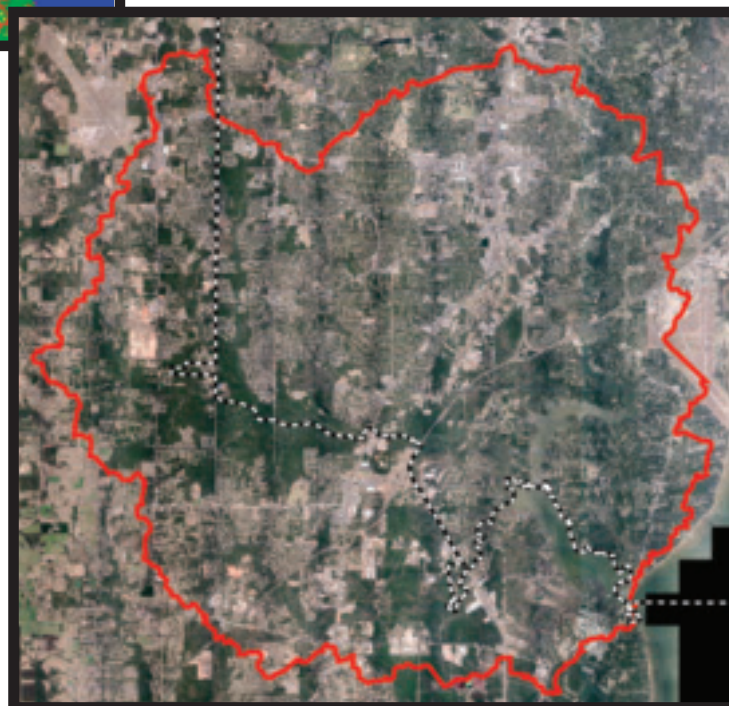
An aerial photograph taken in March 2002 of the Dog River watershed (delineated with red line) and Mobile City limits (delineated with dashed line). The City of Mobile GIS Department used color orthophotos to create this image.

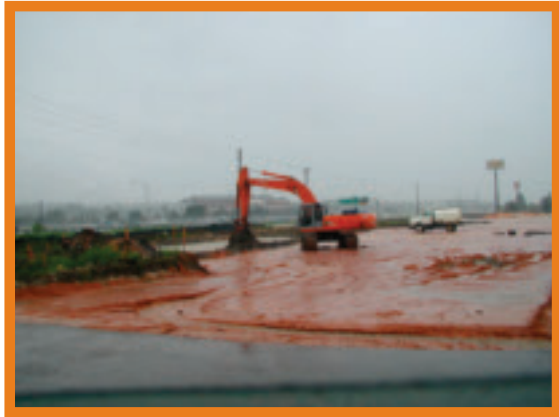
Commercial construction site in the Dog River watershed with minimal soil erosion control

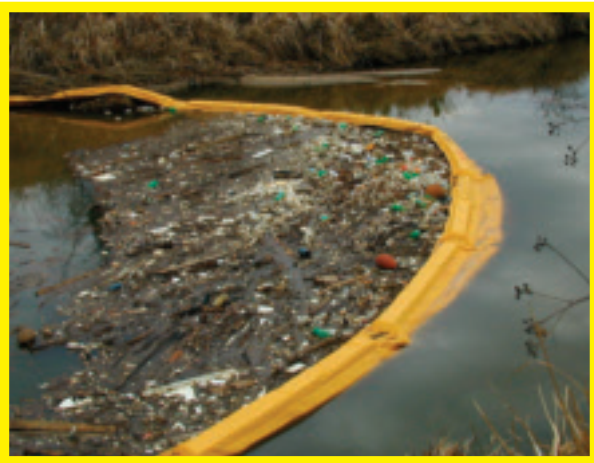
A sediment curtain on Moore Creek catches more litter than silt.

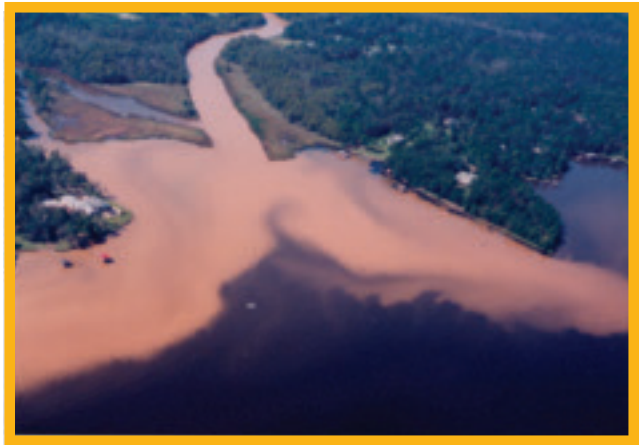
Aerial photograph, taken by Gerritt Carver in 1998, showing a sediment plume entering Dog River after heavy rainfall associated with Hurricane Georges

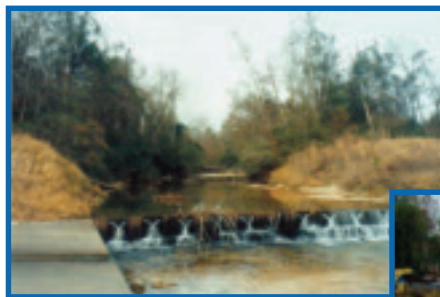
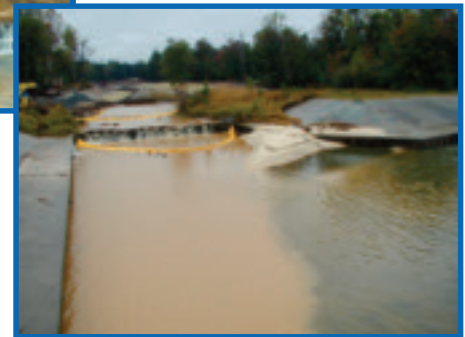
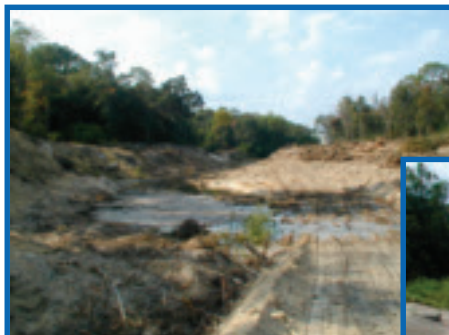
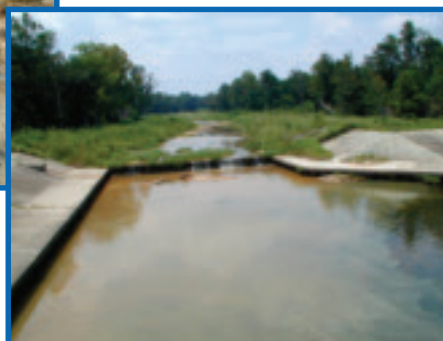
- This series of photos is of Moore Creek, an urban stream that has undergone extensive alterations.
- The City of Mobile has straightened and armored much of the channel to more efficiently convey stormwater runoff and prevent flooding and erosion.
